REPORT OF  
INVESTIGATION & DEVELOPMENT  
OF  
PRELIMINARY COSTS TO REHABILITATE  
WORSHAM STREET BRIDGE

FOR  
CITY OF DANVILLE, VIRGINIA  
DEPARTMENT OF PUBLIC WORKS

AUGUST 2, 2004

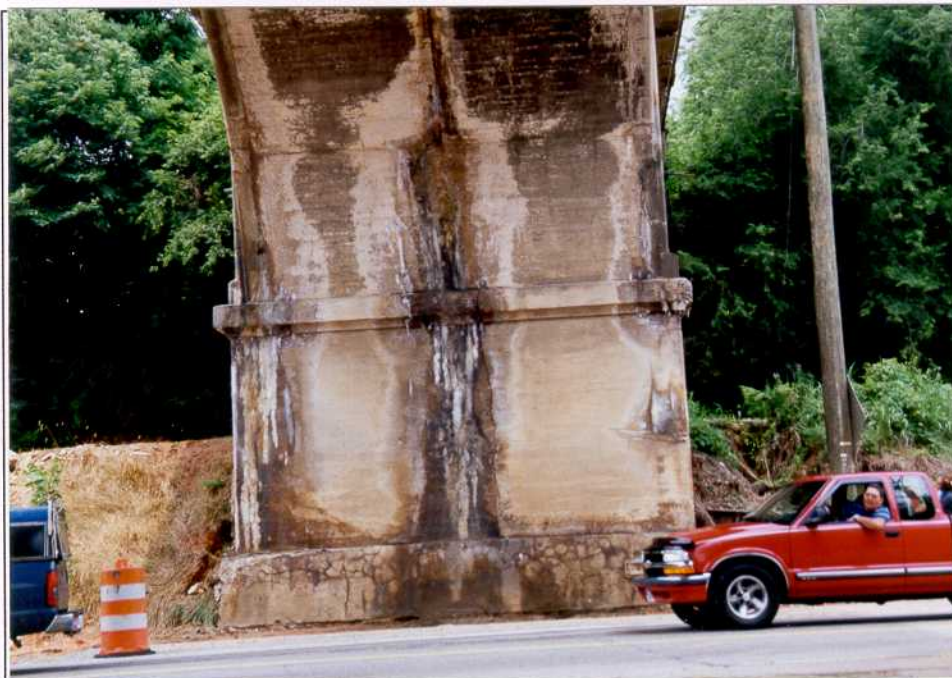
C215-21

There is cracking, spalling and signs of efflorescence at the abutments. At Pier 2 there is a vertical crack approaching 1 1/2 inch in width which is located near the centerline of the roadway. The other piers show extensive cracking, varying in width from hairline to approximately 3/16 of an inch. This cracking appears to be most extensive at Piers 3 through 7. There is extensive concrete scaling on the tops of some of the pier caps. Pier 7 and 8 appear to be the most extensive. The general condition of the piers and abutments is fair.

**PIER 2, SPAN B - NOTE VERTICAL CRACK.**

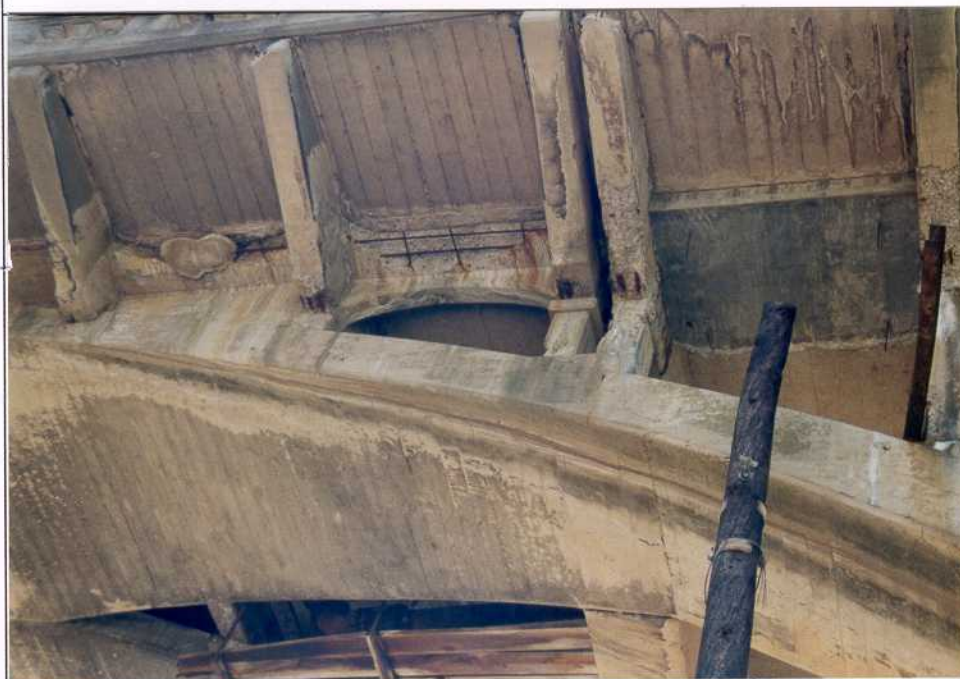
A104-9

**SEVERE DETERIORATION, FLOORBEAM, DECK, COLUMNS,  
UPSTREAM SIDE, SPAN B OVER ROUTE 58.**

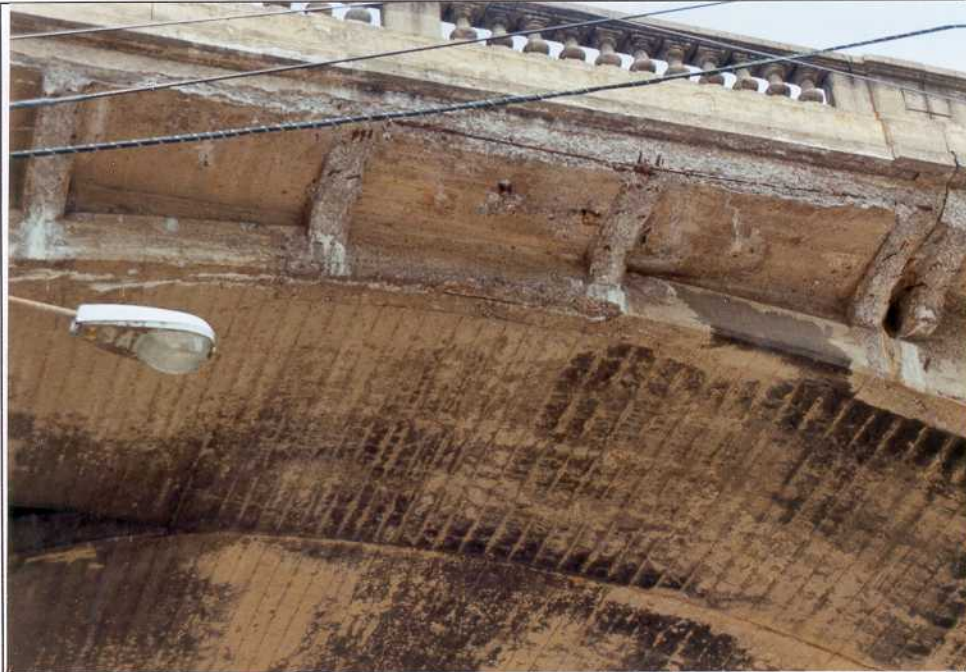
A106-1

**SPALLED AND DELAMINATED CONCRETE, CORRODED REINFORCING STEEL, DOWNSTREAM SIDE, SPAN B FLOORBEAMS AND DECK.**

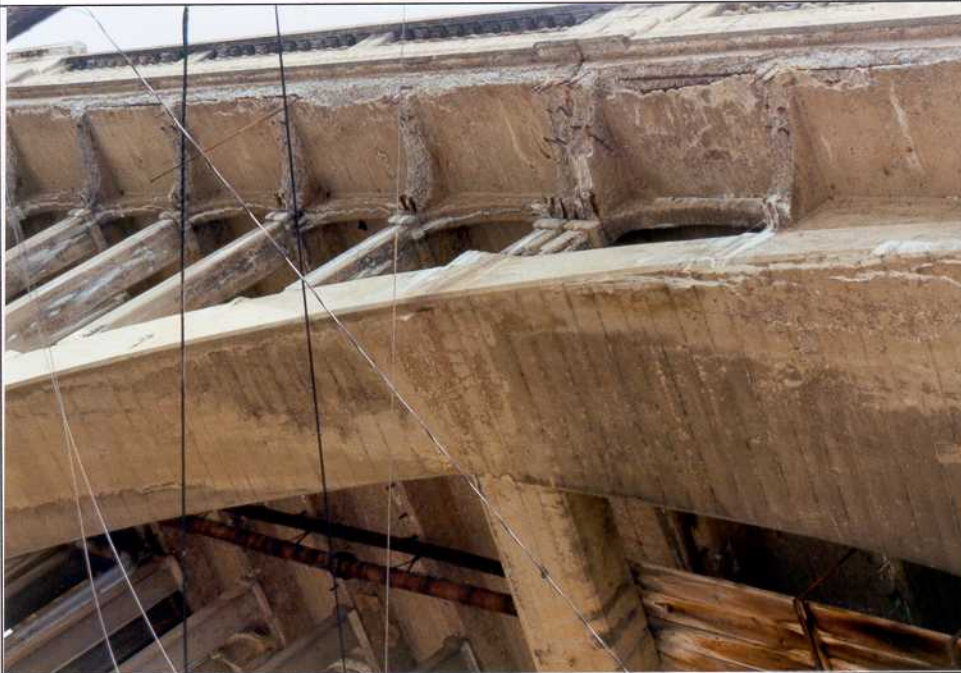
A106-2

**SPALLED AND DELAMINATED CONCRETE, CORRODED REINFORCING STEEL, DOWNSTREAM SIDE, SPAN B FLOORBEAMS AND DECK.**

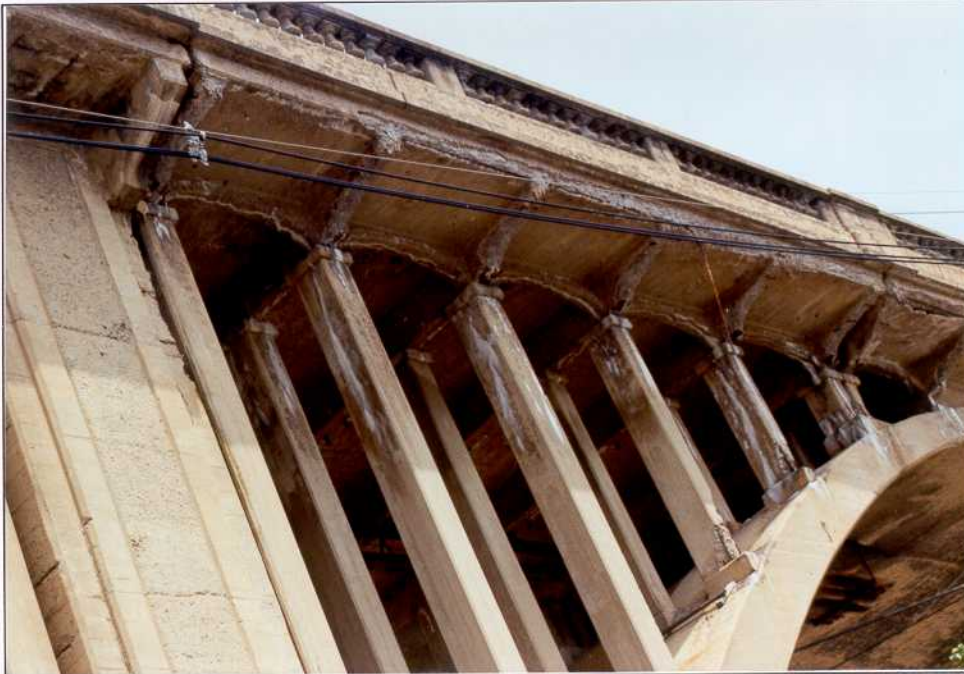
**A106-3**

**SPALLED AND DELAMINATED CONCRETE, CORRODED  
REINFORCING STEEL, DOWNSTREAM SIDE, SPAN B  
FLOORBEAMS AND DECK.**

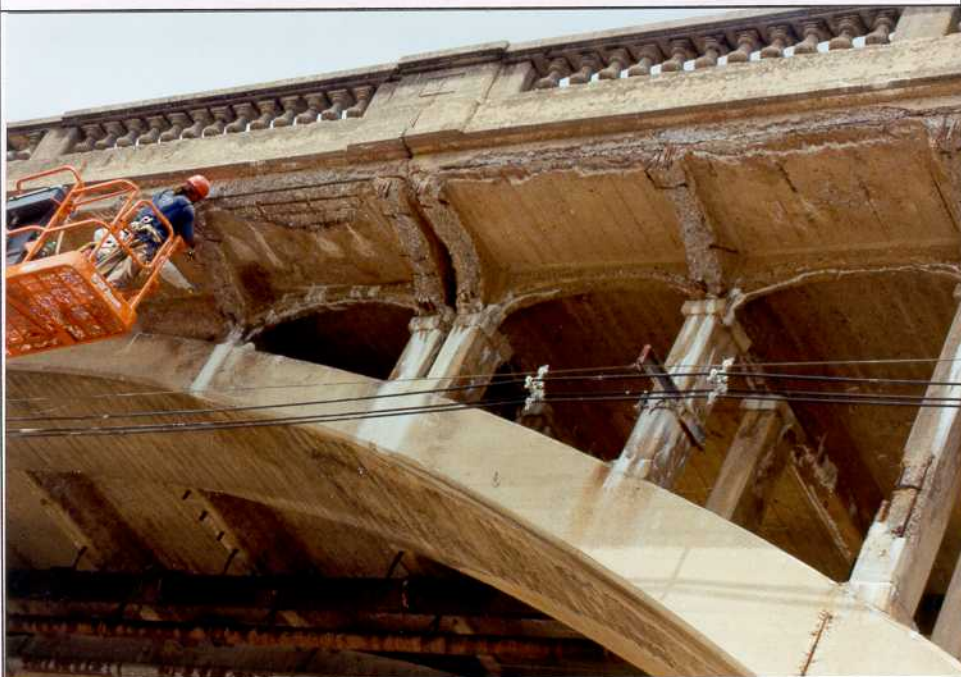
**A106-4**

**SPALLED AND DELAMINATED CONCRETE, CORRODED  
REINFORCING STEEL, DOWNSTREAM SIDE, SPAN D.**

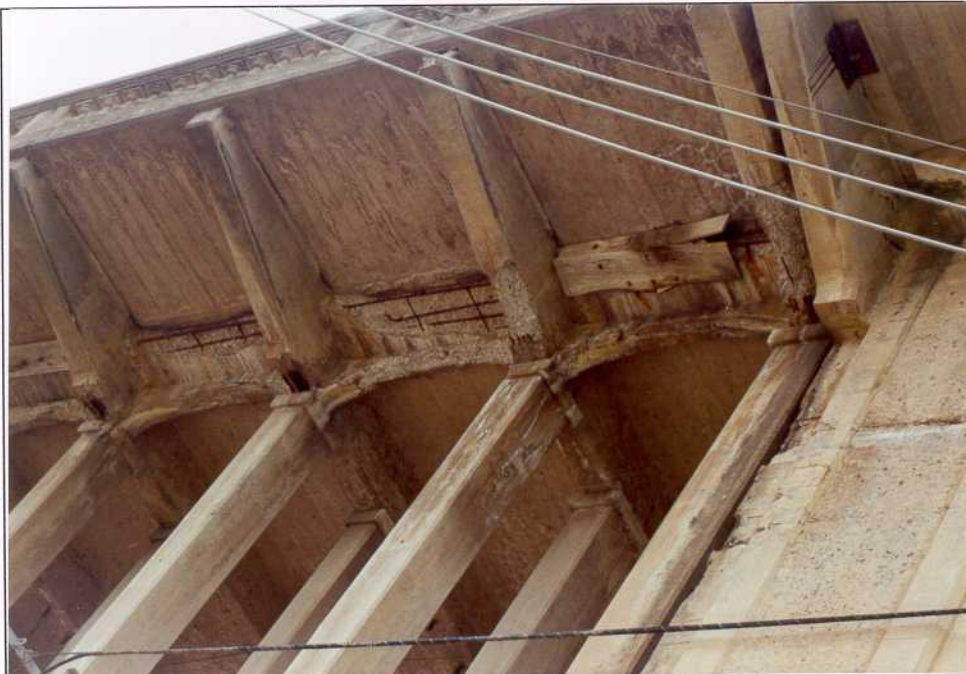
**A106-5**

**SPALLED AND DELAMINATED CONCRETE, REINFORCING  
STEEL, UPSTREAM SIDE, SPAN B.**

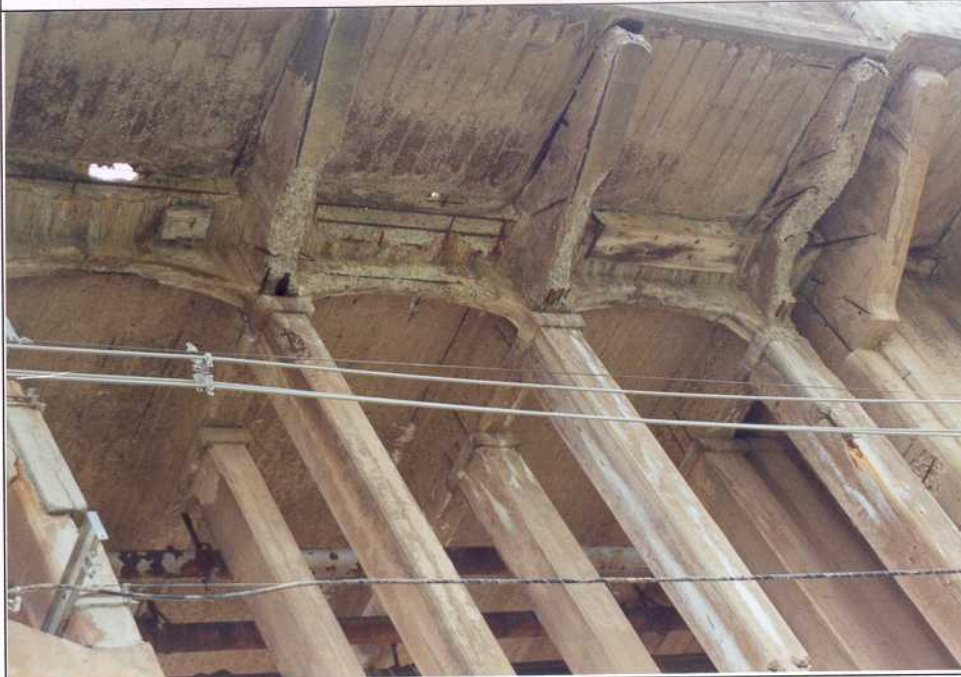
**A106-6**

**SPALLED AND DELAMINATED CONCRETE, REINFORCING  
STEEL, UPSTREAM SIDE, SPAN C.**

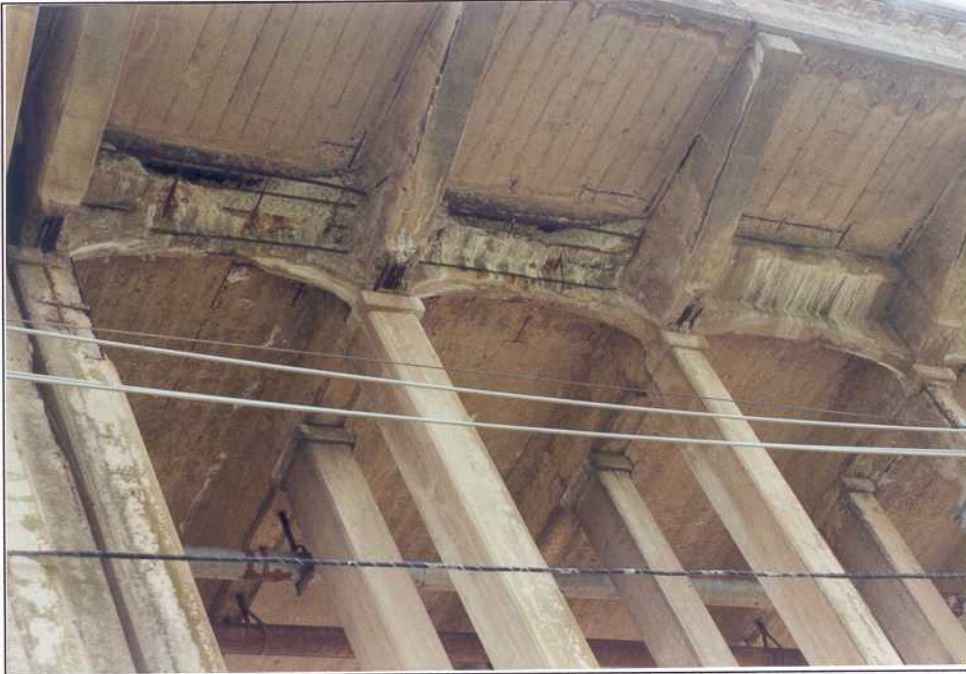
A106-7

**SPALLED AND DELAMINATED CONCRETE, REINFORCING  
STEEL, UPSTREAM SIDE, SPAN D.**

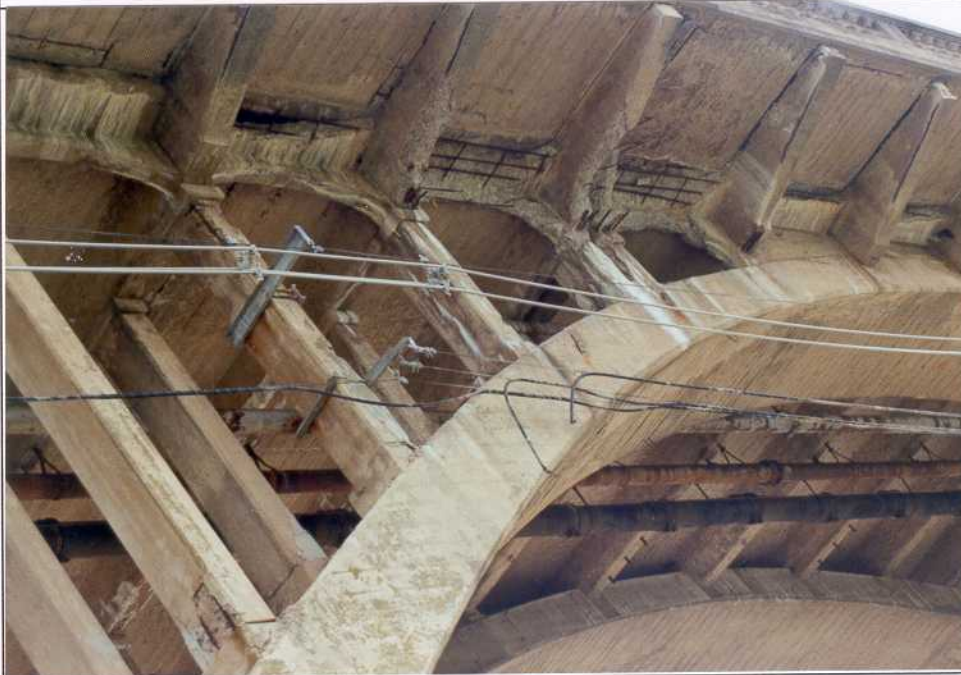
A106-8

**SPALLED AND DELAMINATED CONCRETE, REINFORCING  
STEEL, UPSTREAM SIDE, SPAN D.**

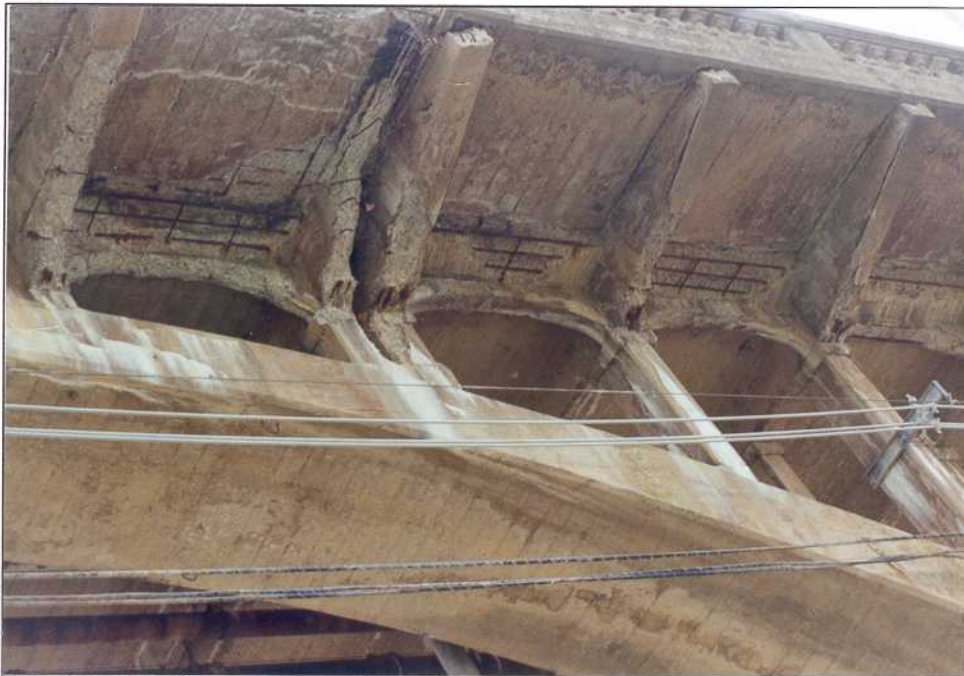
**A106-9**

**SPALLED AND DELAMINATED CONCRETE, REINFORCING STEEL, UPSTREAM SIDE, SPAN D. NOTE ONE FLOORBEAM CANTILEVER PRACTICALLY NON-EXISTENT.**

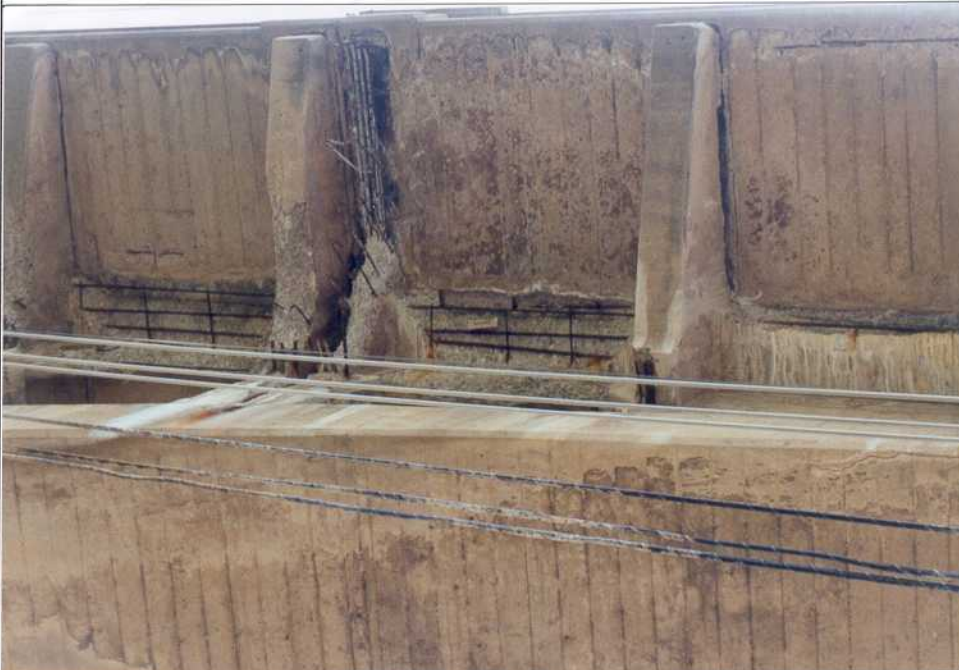
**A106-10**

**SPALLED AND DELAMINATED CONCRETE, REINFORCING STEEL, UPSTREAM SIDE, SPAN D. NOTE THE FLOORBEAM CANTILEVER THAT IS PRACTICALLY NON-EXISTENT.**

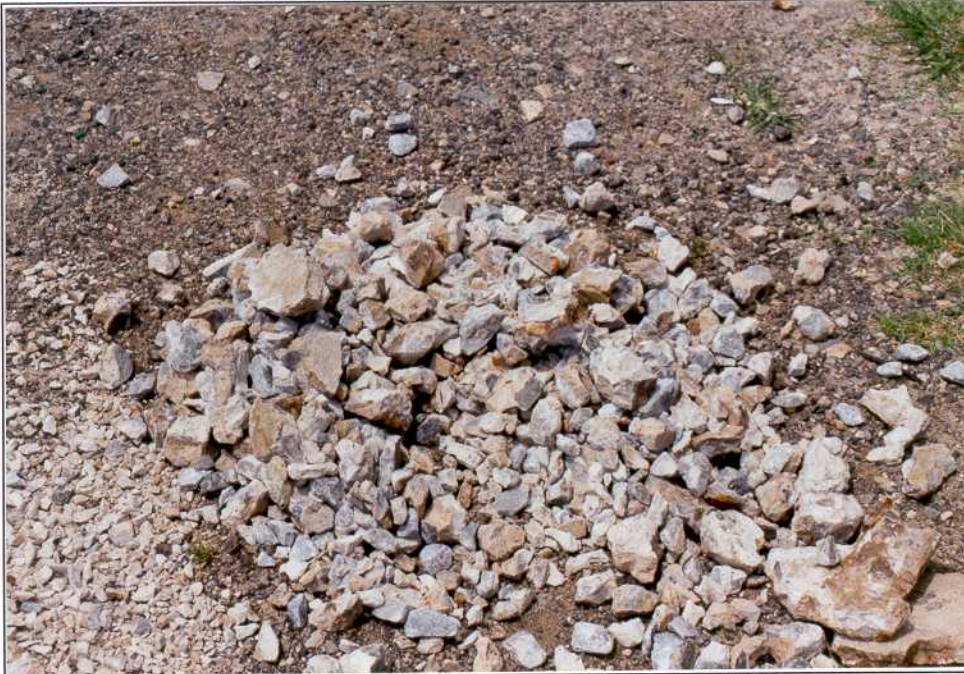
**A106-11**

**REMOVED LOOSE CONCRETE ON GROUND AT PIER 4.**

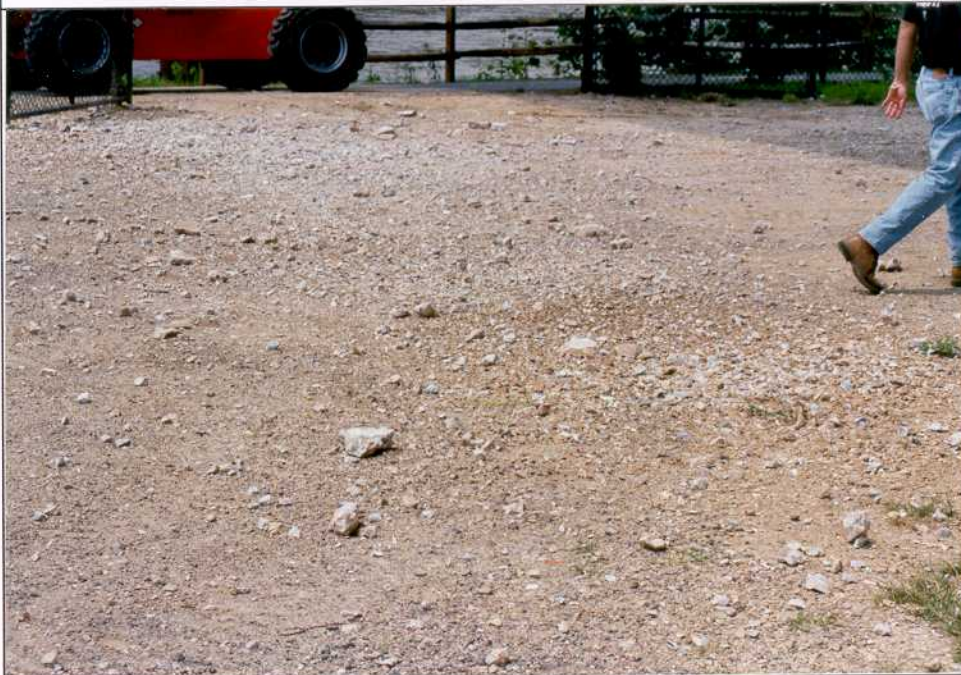
**A106-12**

**REMOVED LOOSE CONCRETE ON GROUND UNDER SPAN D.**

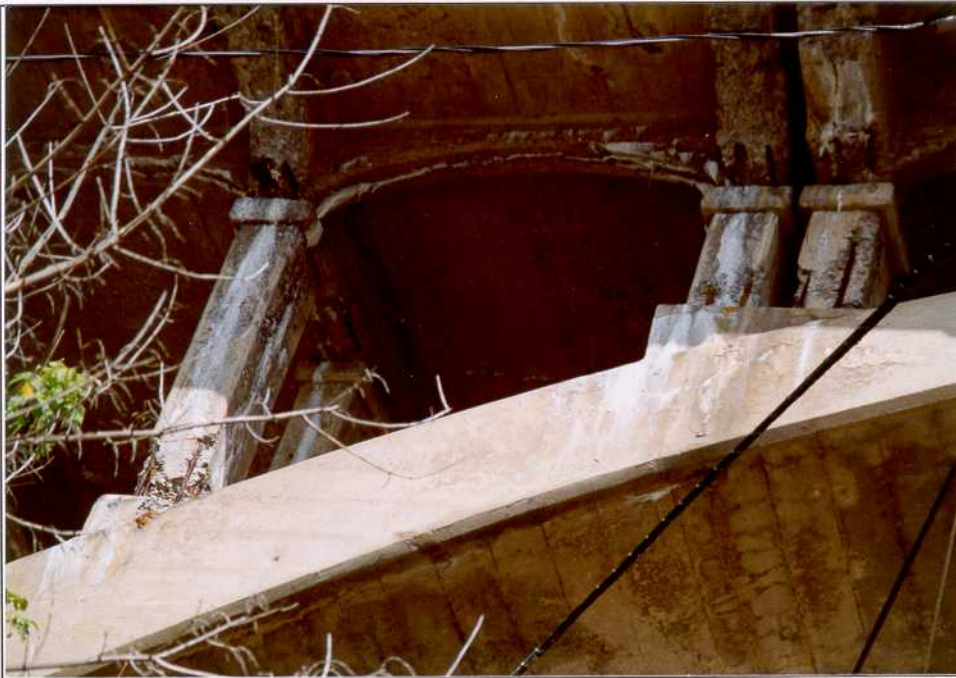
A104-8

SEVERE DETERIORATION, FLOORBEAM, DECK, COLUMNS, ARCH, DOWNSTREAM SIDE, SPAN B OVER ROUTE 58.

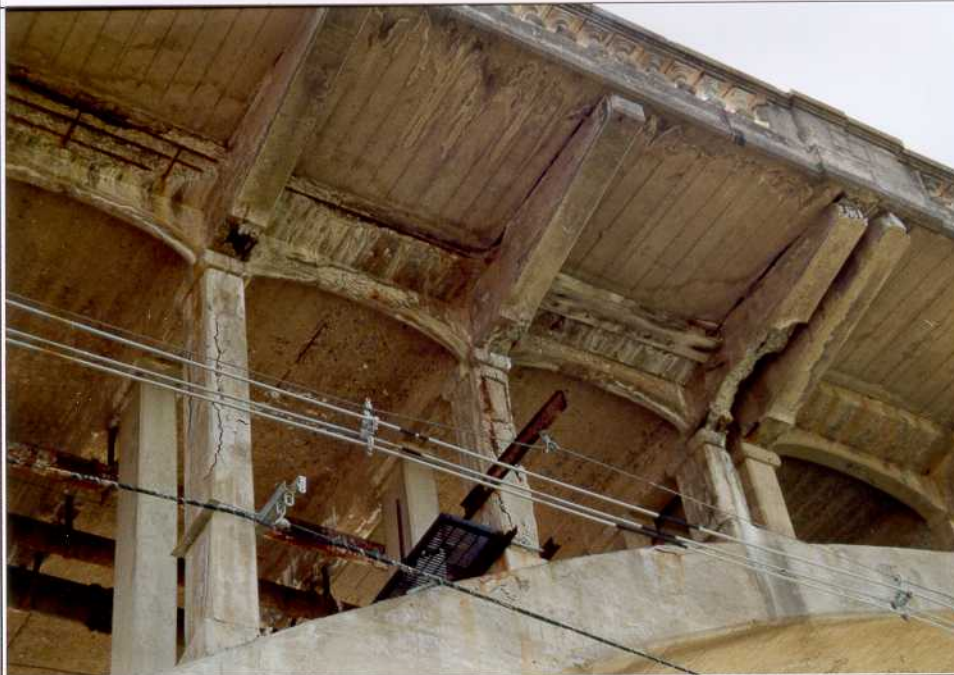
A104-10

SEVERE DETERIORATION, FLOORBEAM, DECK, COLUMNS, ARCH, UPSTREAM SIDE, SPAN C.

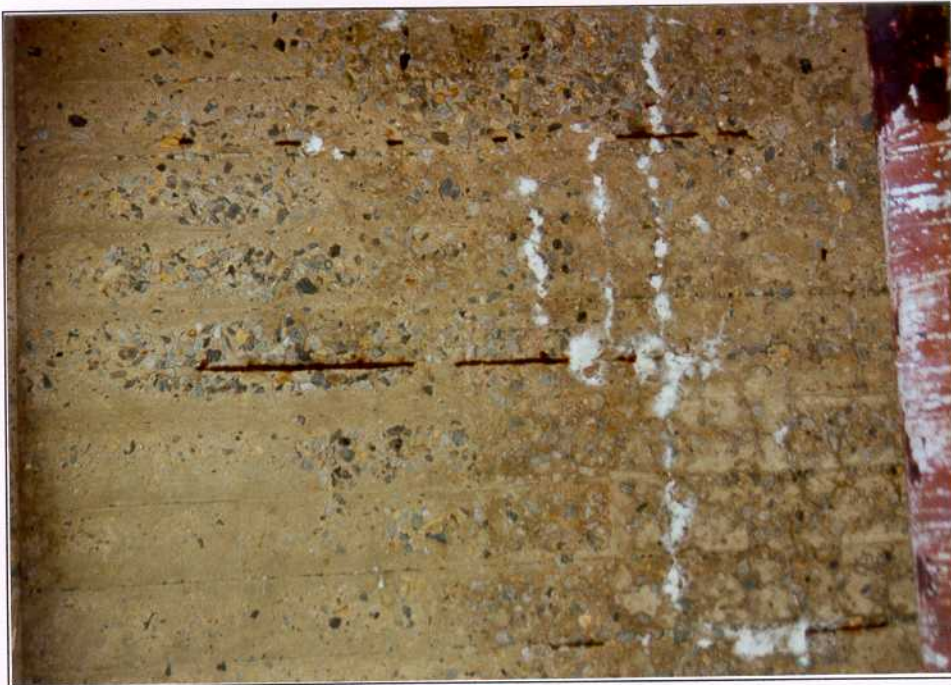
C215-9

**SPAN C, APPROXIMATELY 30' FROM PIER 3 - NOTE  
DETERIORATED CONCRETE ON UNDERSIDE OF DECK.**

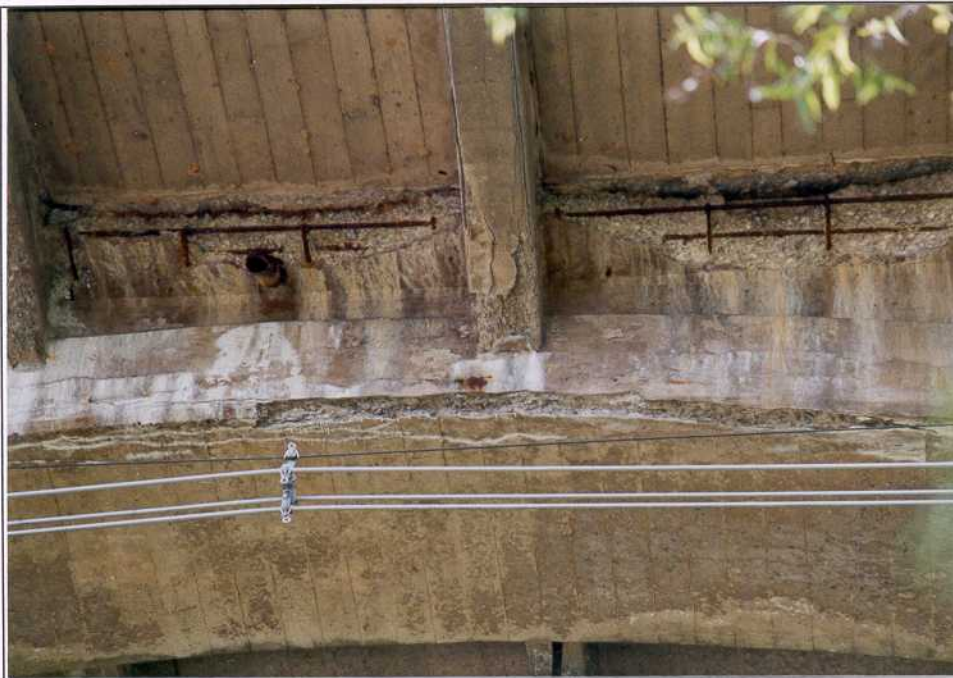
**A105-6**

**SEVERE DETERIORATION, DECK OVERHANG, FLOORBEAMS,  
UPSTREAM ARCH, NEAR CROWN, SPAN G.**

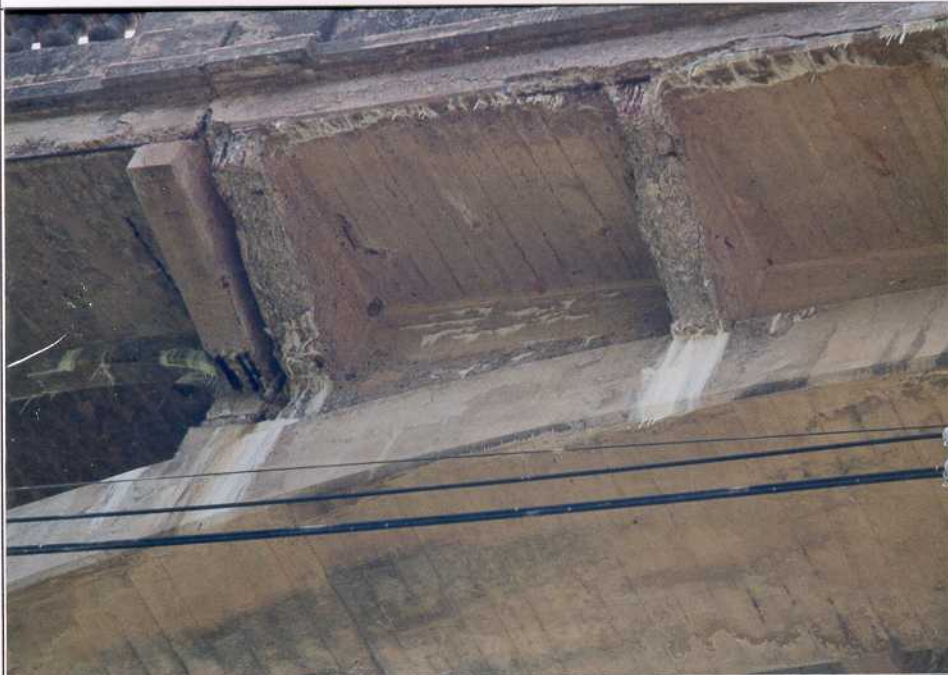
**A105-9**

**SEVERE DETERIORATION, DECK OVERHANG, SPAN G.**

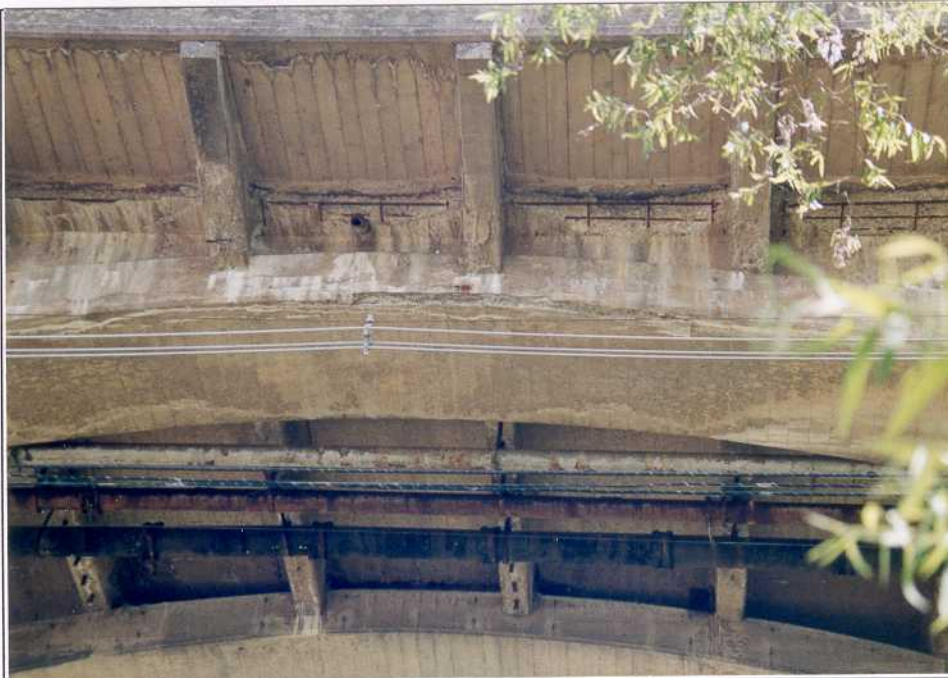
**A105-5**

**SEVERE DETERIORATION, DECK OVERHANG, FLOORBEAMS,  
UPSTREAM ARCH, SPAN G.**

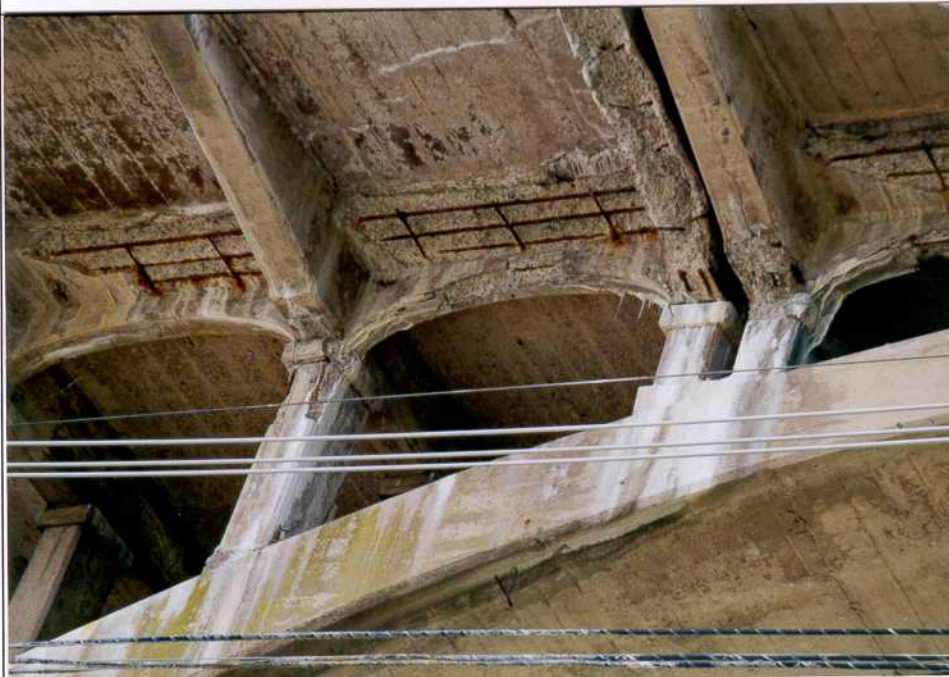
**A105-7**

**SEVERE DETERIORATION, DECK OVERHANG, FLOORBEAM,  
DOWNSTREAM ARCH NEAR CROWN, SPAN G .**

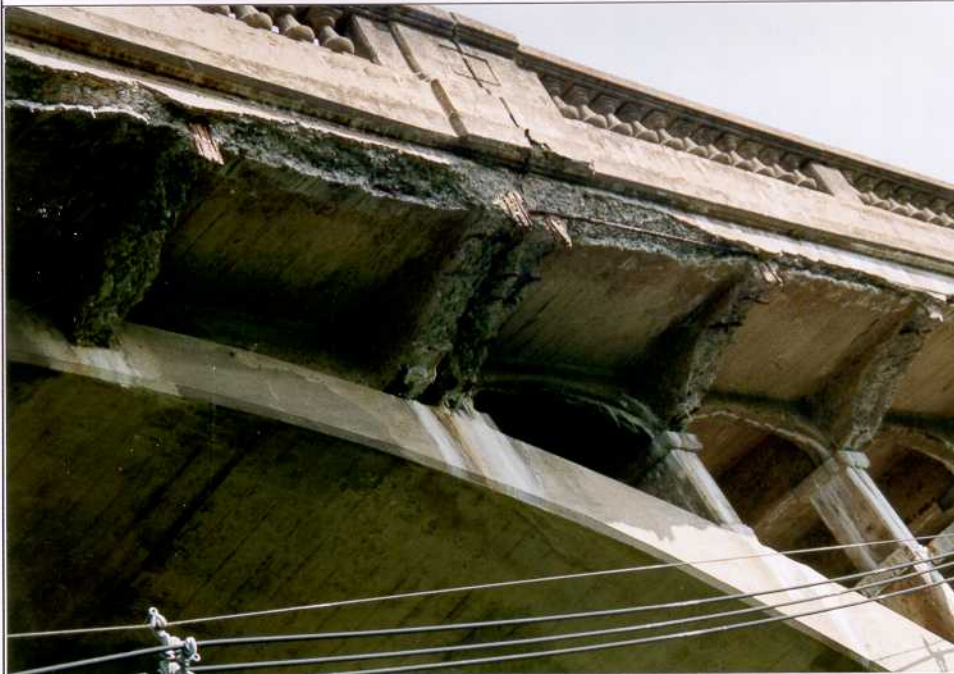
**A104-4**

**SEVERE DETERIORATION, FLOORBEAM, DECK, COLUMNS, DOWNSTREAM SIDE, SPAN H.**

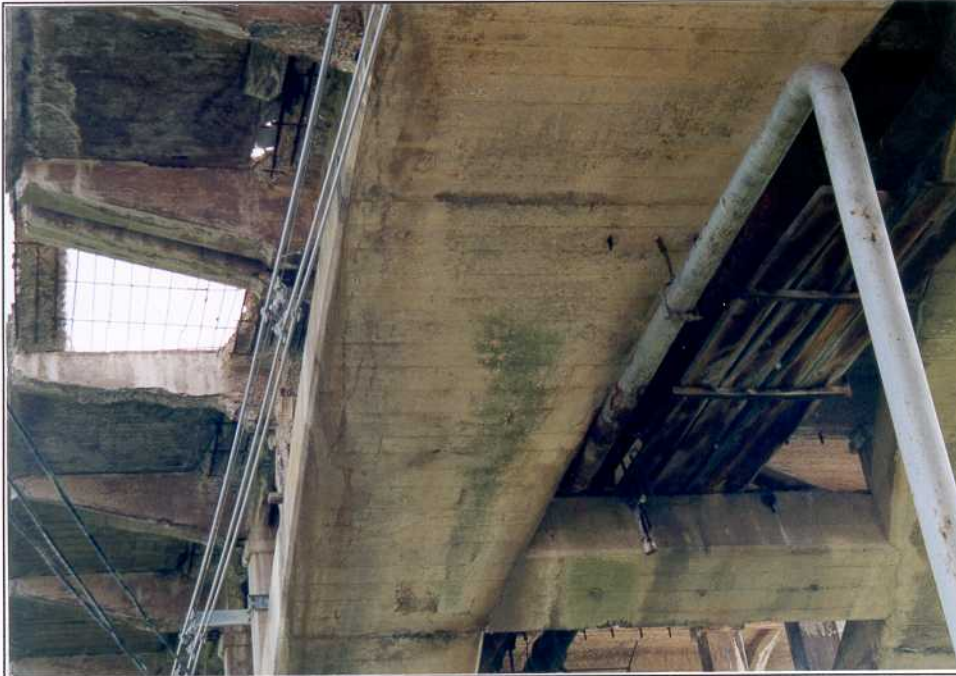
**A104-2**

In June 2004, a contractor's crew was working on repairs to the sidewalk when a section the full width of sidewalk and several feet long fell out to the ground leaving only the reinforcing bars in place. Inspection of other areas of sidewalk revealed a number of other areas that were in similar condition to the one that collapsed.

**SPAN H - SIDEWALK FAILURE DURING REPAIR OPERATION.**

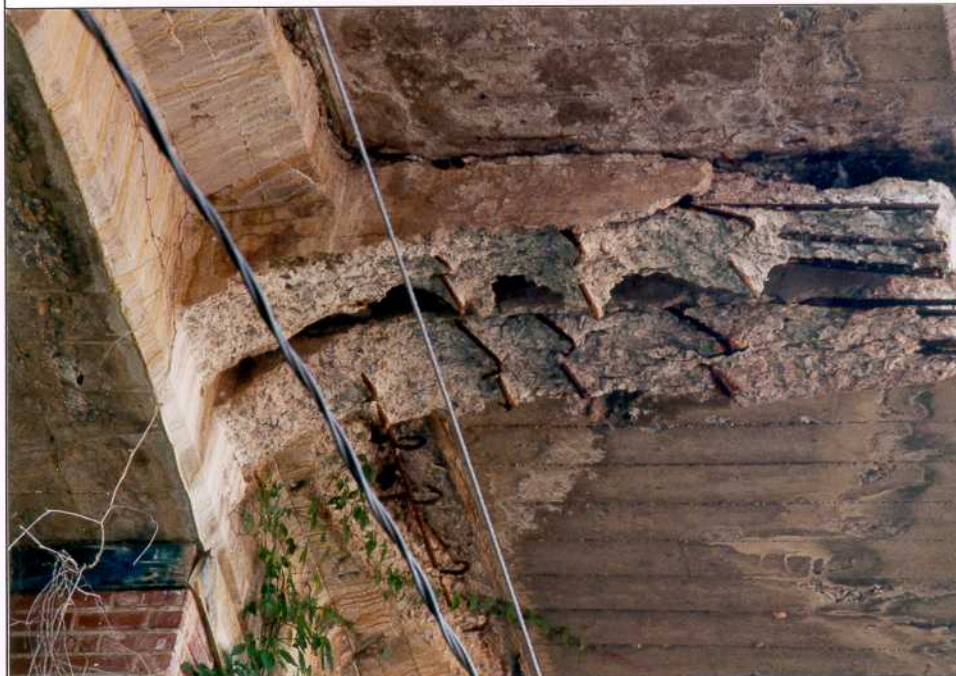
**A104-1**

**SEVERE DETERIORATION, FLOORBEAM, CANTILEVER AND DECK OVERHANG, SPAN J, UPSTREAM SIDE.**

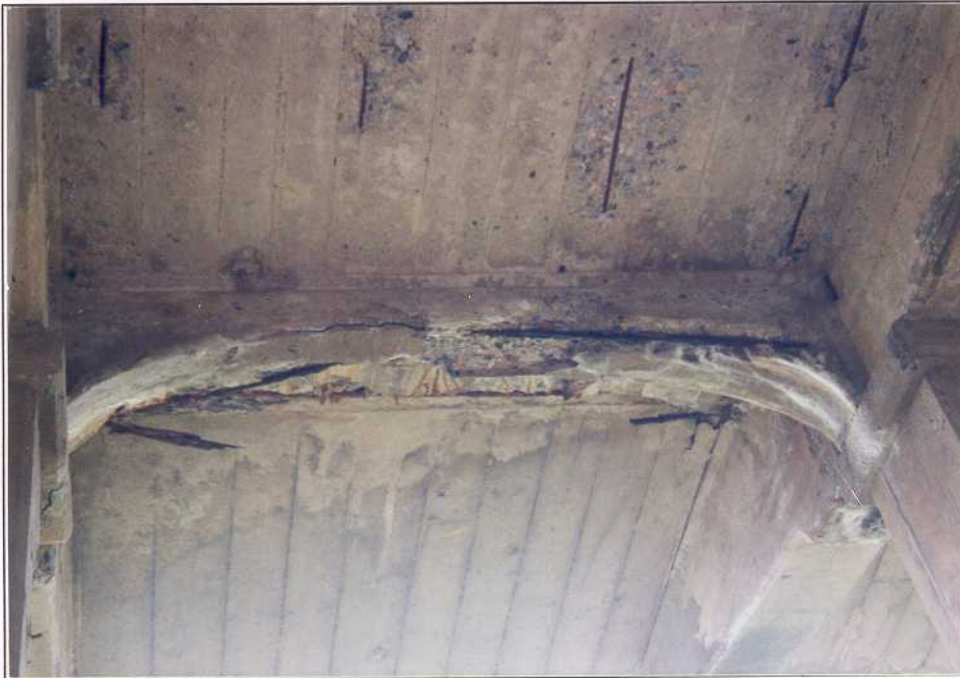
**C216-7**

**UPSTREAM STRINGER, SPAN C - NOTE DETERIORATED CONCRETE.**

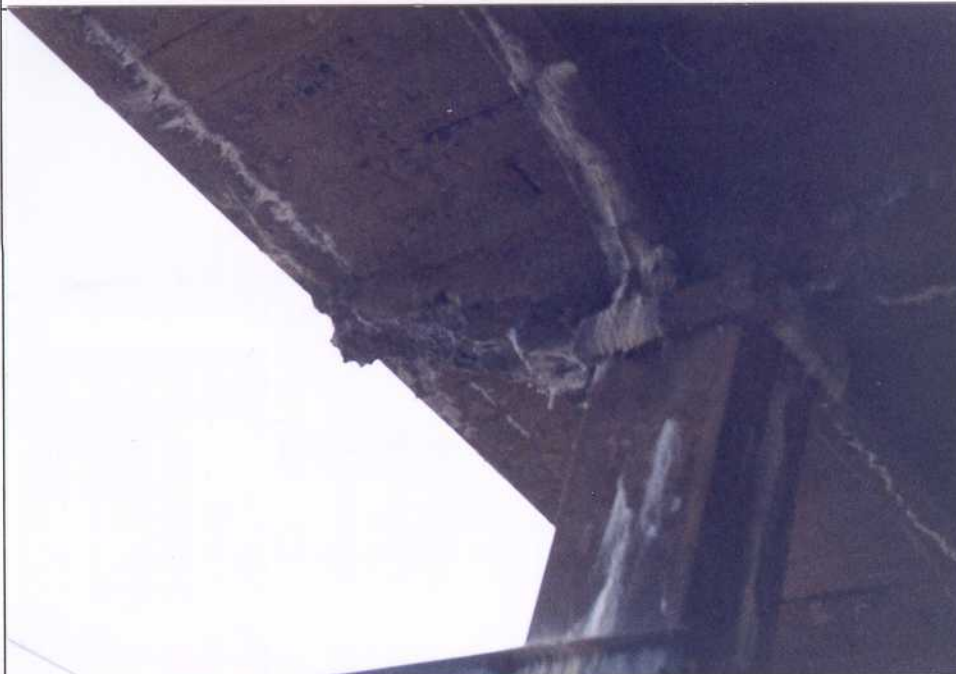
**C216-3**

**SIDEWALK FLOORBEAM ON DOWNSTREAM SIDE OF SPAN C - NOTE DETERIORATED CONCRETE.**

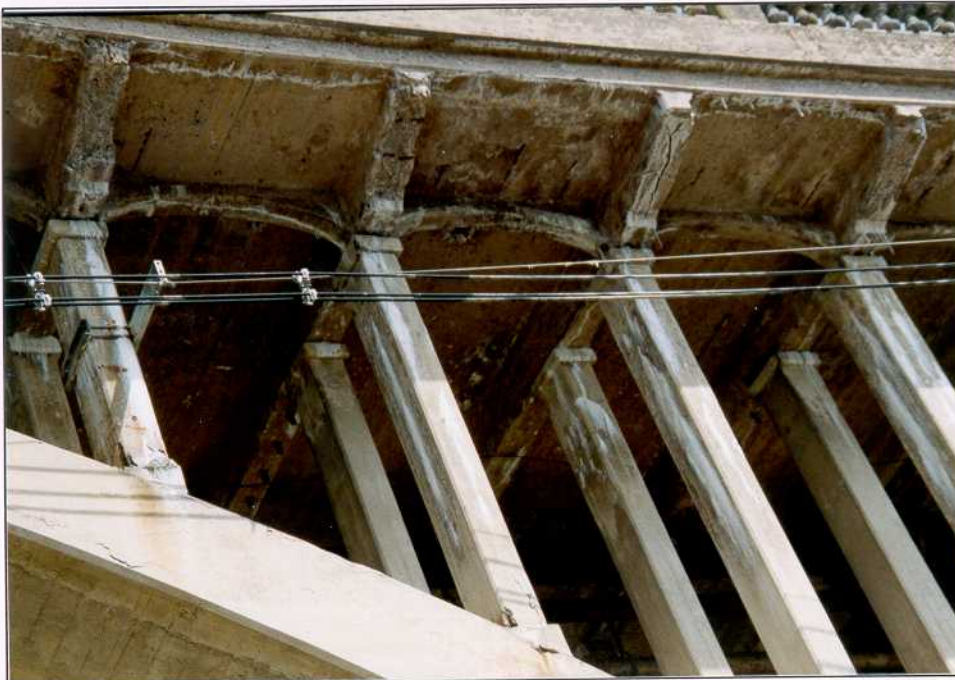
**A104-11**

**SEVERE DETERIORATION, FLOORBEAM, DECK, COLUMNS,  
DOWNSTREAM SIDE, SPAN C.**

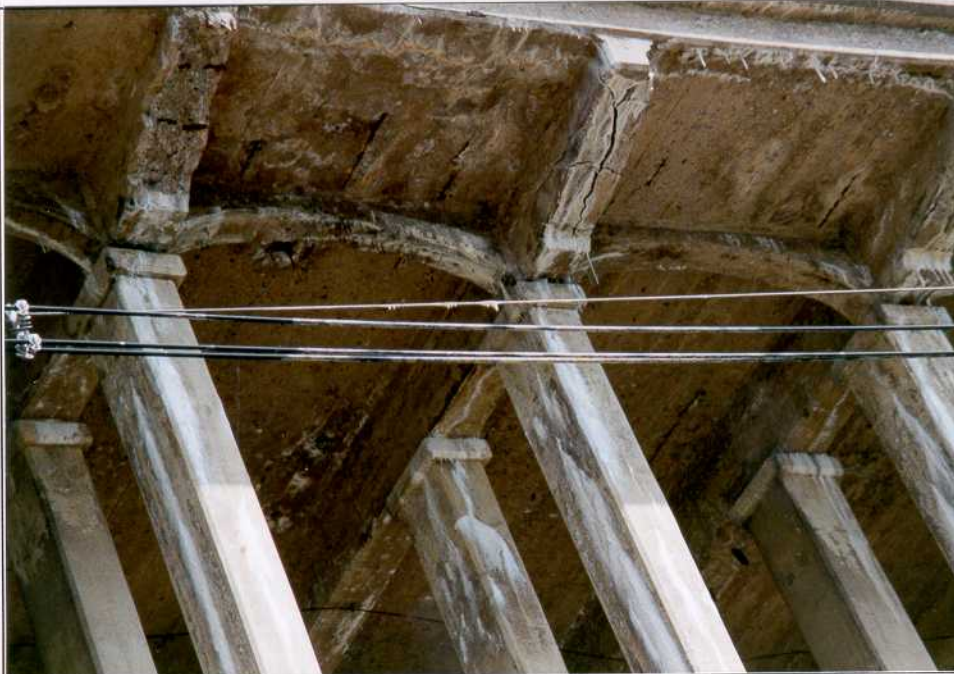
**A104-12**

**SEVERE DETERIORATION, FLOORBEAM, DECK, COLUMNS,  
DOWNSTREAM SIDE, SPAN C.**

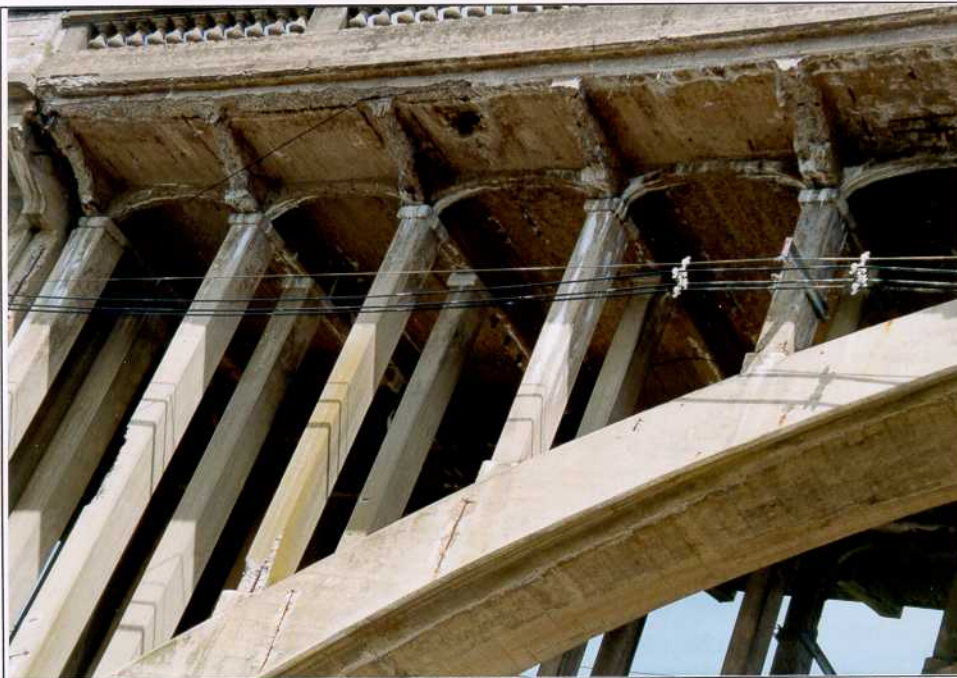
**A104-13**

**SEVERE DETERIORATION, FLOORBEAM, DECK, COLUMNS,  
DOWNSTREAM SIDE, SPAN C.**

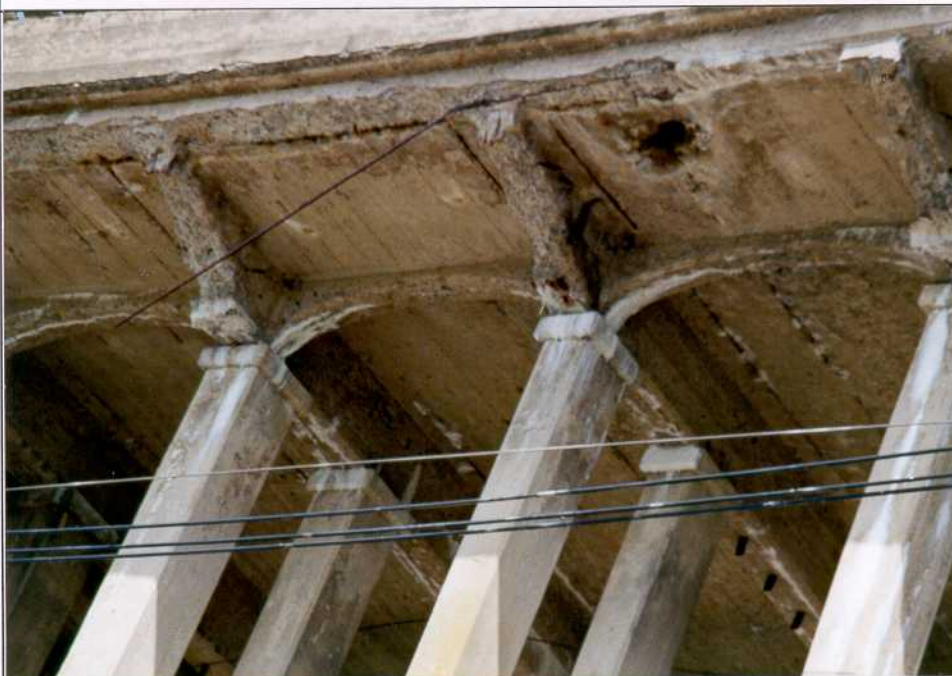
**A104-14**

**SEVERE DETERIORATION, FLOORBEAM, DECK, COLUMNS,  
DOWNSTREAM SIDE, SPAN C.**

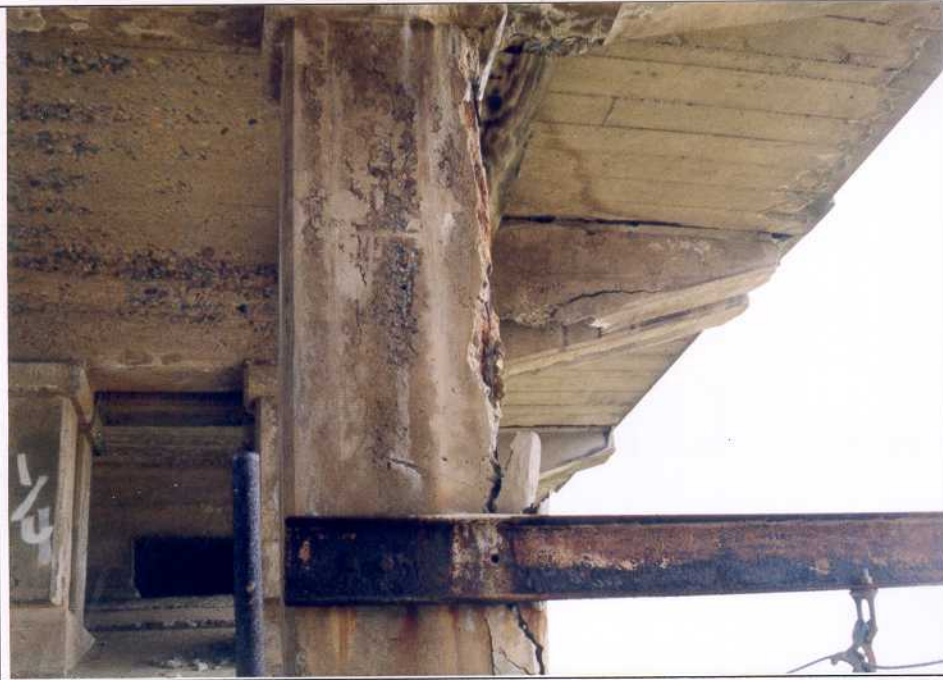
**C215-8**

**SPALLED CONCRETE WITH EXPOSED STEEL, COLUMN D6,  
SPAN C.**

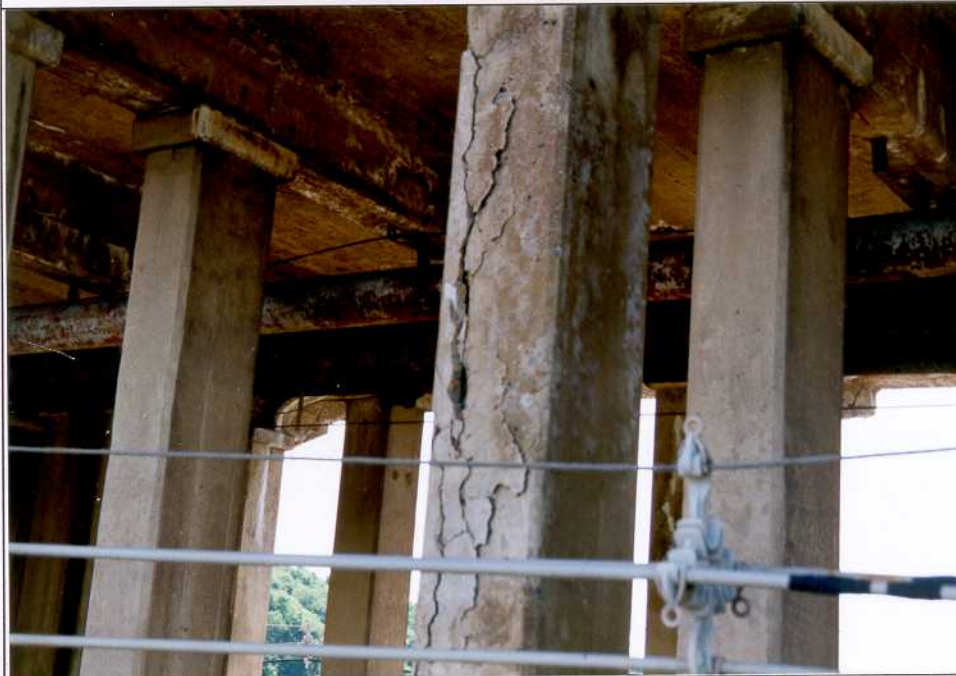
**C216-18**

**UPSTREAM ARCH, COLUMN D5, SPAN C - NOTE SPALLED/  
DELAMINATED CONCRETE.**

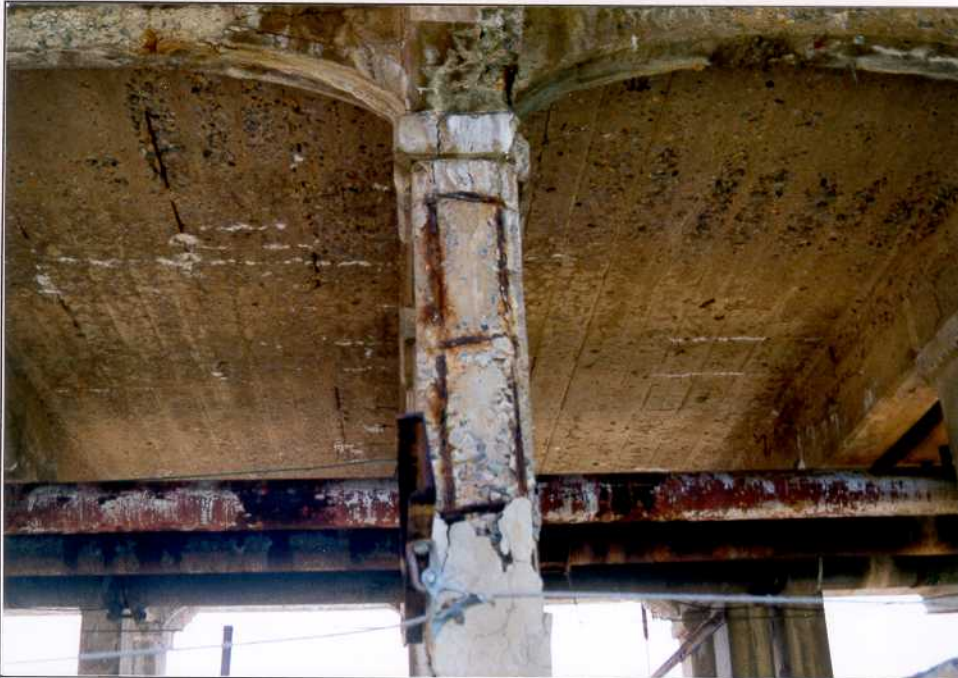
**C216-16**

**UPSTREAM ARCH, COLUMN D6, SPAN C - NOTE SPALLED CONCRETE.**

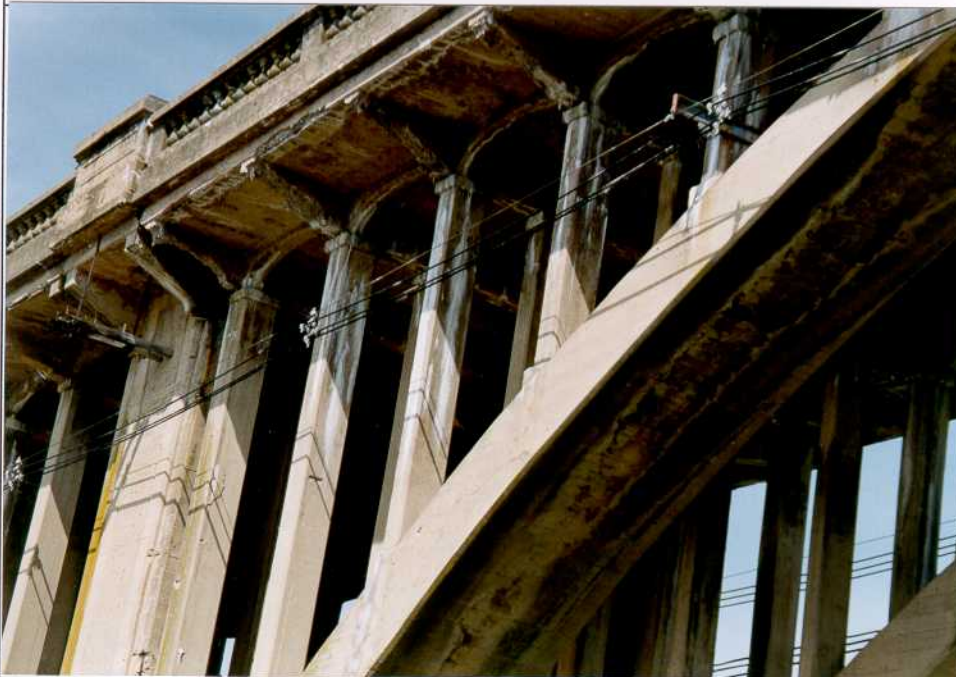
**A104-17**

**SEVERE DETERIORATION, DECK, FLOORBEAMS, COLUMNS, SPAN D, DOWNSTREAM ARCH NEAR PIER 5.**
